CMU Biorobotics Lab Deployment Report

EVN Zwentendorf Nuclear Power Plant
Zwentendorf, Austria

May 13-14, 2013

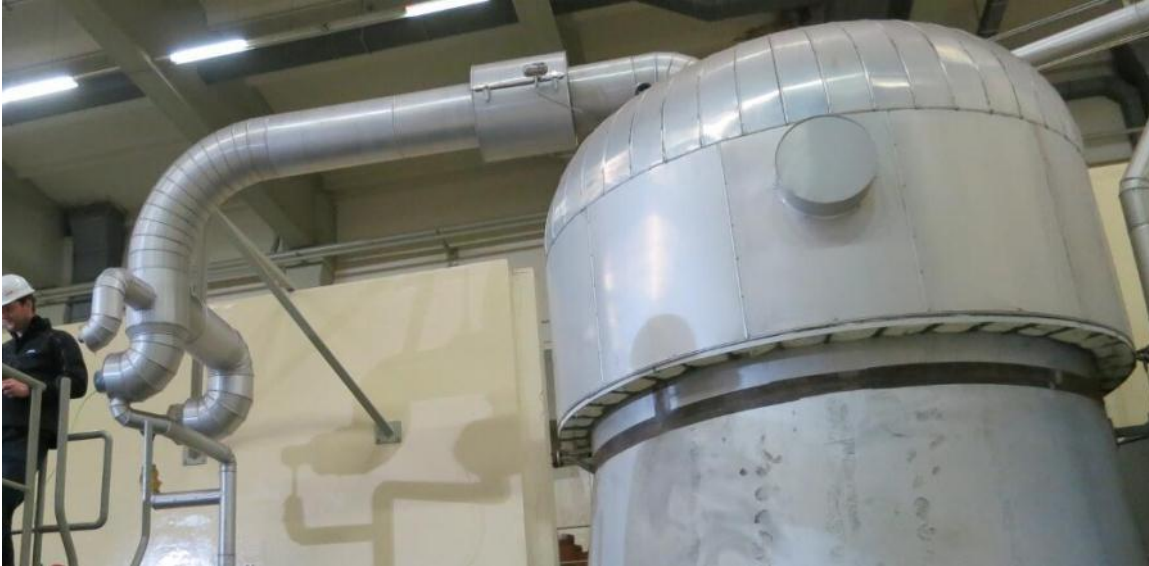
Figure 6: 6" Steam Piping Leading to Moisture Separator Reheater Vessel

The next demonstration involved inserting the robot into a 6" steam line that connects the turbine to the moisture separator reheater vessel. This particular steam line was cut open approximately 15 feet away from the vessel. The steam line begins horizontally oriented immediately following the open cut, and then contains a 90 degree bend to vertical, followed by two junctions coming into the vertical section of the pipe, and then levels off to horizontal. Once horizontal, the pipe proceeds approximately 12 feet where it drops vertically into the top of the moisture separator reheater vessel (see Fig. 6). The robot was inserted into the open cut, climbed through the pipe's bends, and then proceeded along the horizontal portion of the line. While the robots have previously demonstrated their ability to climb inside of pipes and navigate around bends, this deployment was complicated by the fact that several other inlet pipes and junctions were present in the vertical portion of the piping. Despite these complications to the interior surface of the

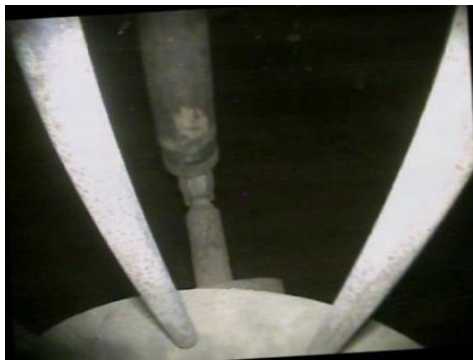
Figure 7: An image of the inside of the moisture separator. The robot is suspending itself from the pipe entering at the top of the vessel

During the inspection, the robot encountered a sensor probe protruding substantially into the horizontal portion of the pipe close to the vessel (Fig. 7). The robot was able to slither under this obstacle. Once the robot reached the vertical drop into the condenser vessel, it slithered forward until it hung by its tether. The robot was lowered by its tether deeper into the moisture separator reheater vessel, while the head was steered by the operator to look inside of the vessel from multiple vantage points (Fig. 8). The robot could have proceeded deeper into the vessel's void space, but the team opted to be conservative and ensure that the robot could be pulled back with the tether. The robot was then pulled back with the tether out of the vessel, into the 6" steam line, and back around the line's bends where it was retrieved at the open cut access point.

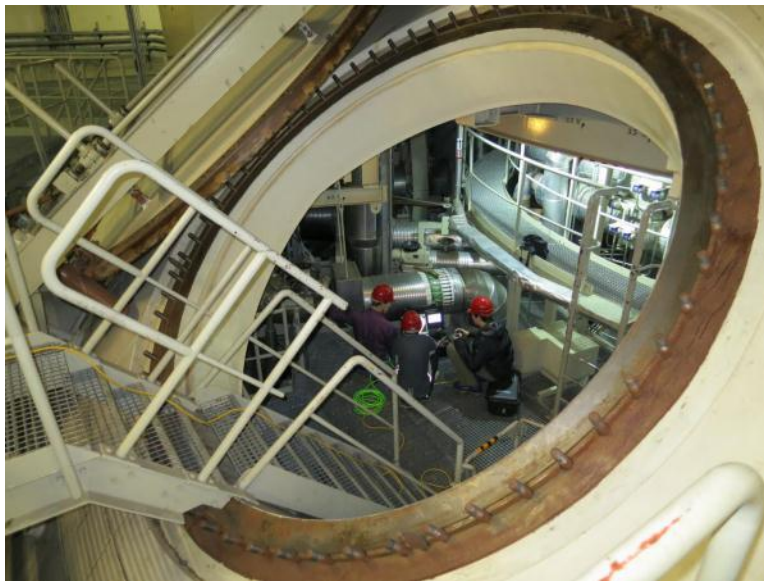
Figure 9: Deploying in the upper area of the reactor.

The CMU Team returned to the Zwentendorf Nuclear Plant for the remainder of the day and performed some more inspections of various sizes of steam lines that travel between the reactor, the condenser, and the turbine. The team entered the reactor core containment vessel, above the reactor, and identified many 18” steam pipes leading towards the reactor or exiting the

containment vessel (Fig 9). One such steam line had a large valve removed, which provided a suitable access port through which the robot could be inserted into the steam line to travel in either direction (Fig. 10).

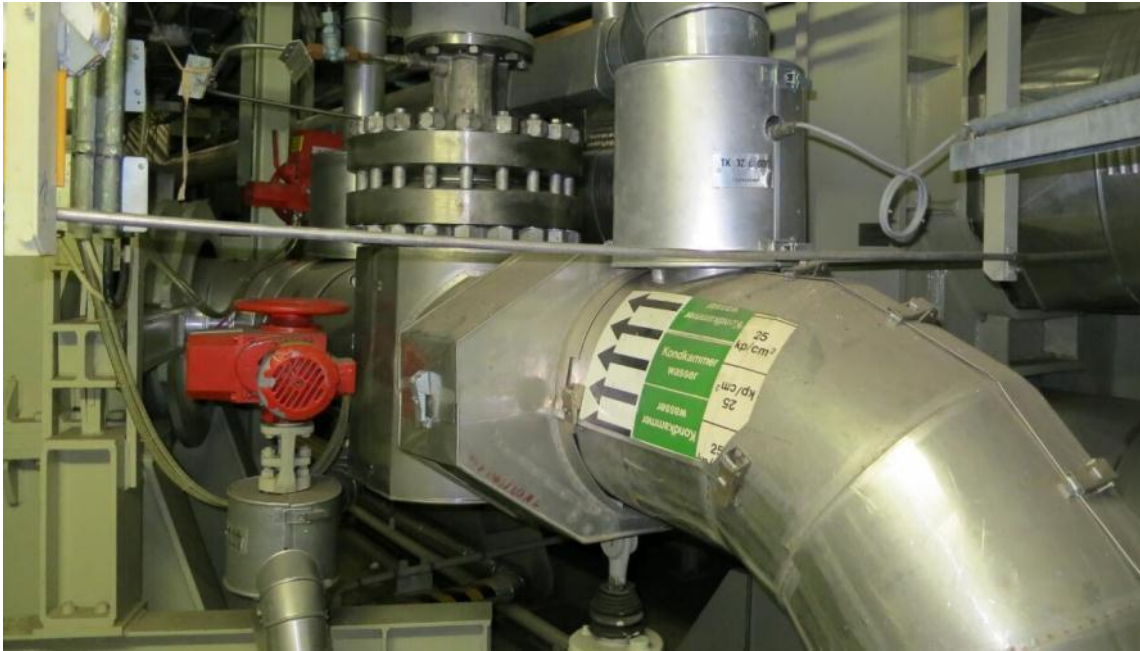
Figure 10: External view of the valve and steam piping that the robot traversed.

First, the robot was driven into the steam pipe away from the reactor. The 18” line horizontally exited the reactor containment vessel, bent 45-degrees to the right, contained a valve capable of completely closing the pipe, and then proceeded vertically down below the floor and into lower portions of the power plant (the team could not fully trace the pipe to its origin). Once the robot was inserted, it slithered along the pipe and maneuvered around the 45-degree bend. The robot encountered a loose bolt and washer that had somehow settled inside the steam pipe (Fig. 11). When the robot reached the valve, it was found to be about 90% closed and did not leave the robot enough space to continue. The team found the control override for the valve and slowly raised the valve while the robot recorded the operation from inside the pipe. Once the valve was sufficiently raised, the robot slithered through the opening. A smaller diameter pipe entered the 18” steam line from the top, just past the valve (Fig. 11), and the robot was able to lift its head up and into this pipe. However, the robot was not able to transition from the bottom of the 18” steam line to climbing vertically into the intersecting line, which suggests an area for future development to enable the robots to inspect as much of the piping network as possible. After lowering the head back into the main 18” steam line, the robot proceeded forward until the pipe transitioned to a vertical drop. Since the robot had already passed through a valve and several bends, the team opted to not lower the robot down the drop. The robot then slithered backwards through the valve it had passed and was retrieved by the team.

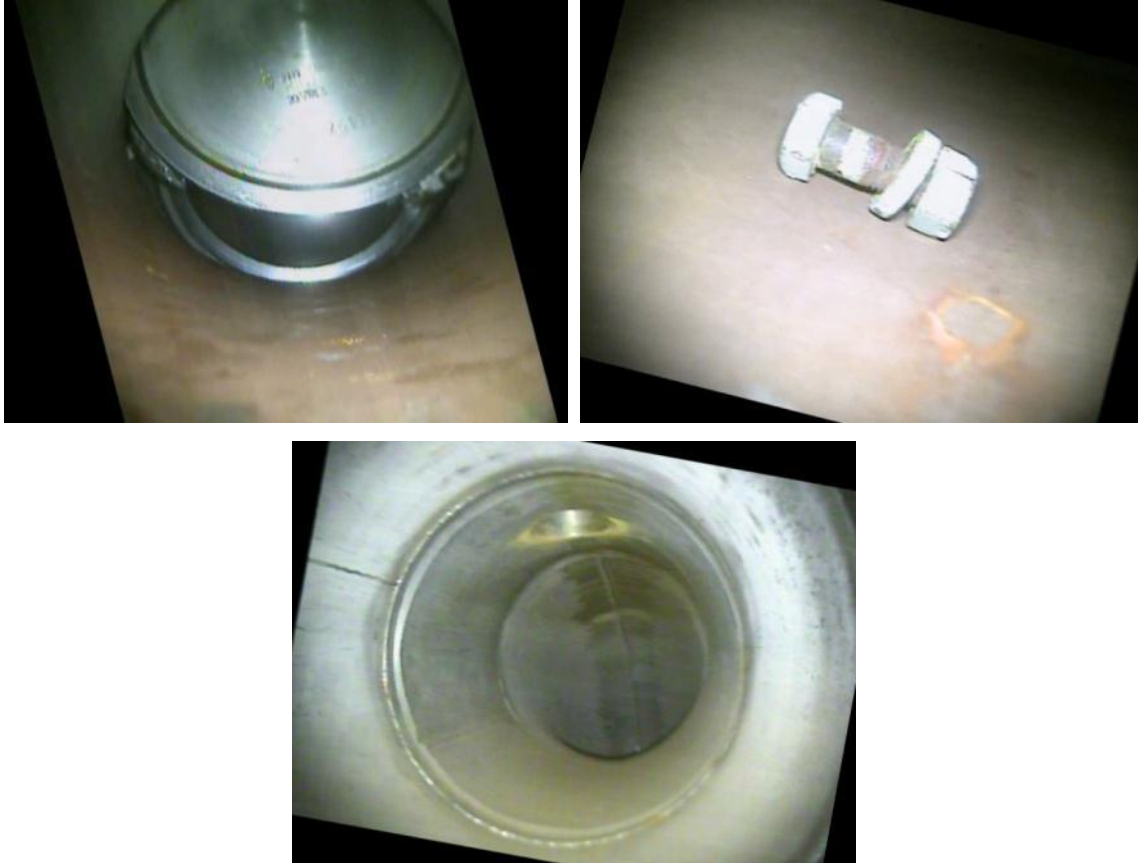
Figure 11: Views from inside the steam pipe in the upper reactor area. Top left, a partially open valve. Top right, a nut and bolt. Bottom, a 90-deg bend in the pipe with a smaller pipe junction.

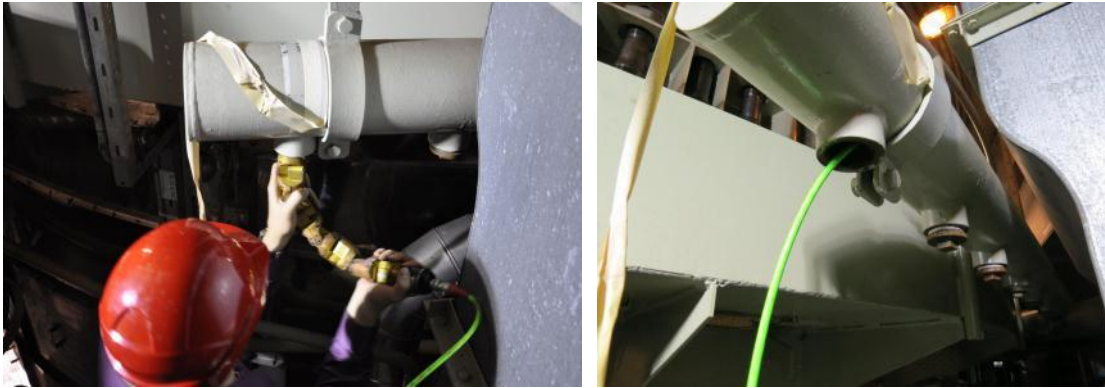
Figure 11: Left, inserting the snake into the nitrogen line. Right, a view down the nitrogen line during the inspection.

The team found an unplugged 2” opening through which the snake robot was inserted into the 6” line. Since the robot’s OD is approximately 2”, the robot had to be carefully inserted into the 2” openings.

Additionally, the 2” openings were positioned at a right angle to the main 6” line. A coordinated effort between the robot operator and the individual inserting the robot into the 2” opening was

required to insert the robot. A few modules at a time were pushed up through the opening and into the 6" line, and then the operator would command those portions of the robot to bend sharply so that they did not hit the top of the 6" line. This procedure was repeated until the entirety of the snake robot was through the 2" opening, around the tight right angle bend, and into the 6" line. From here, the robot slithered forward through the 6" line, including through one of the horizontal bends. The robot was then removed through the initial insertion port.
